# SAFETY ALERT

Date: 29-07-24

## Fire Hydrant Failures

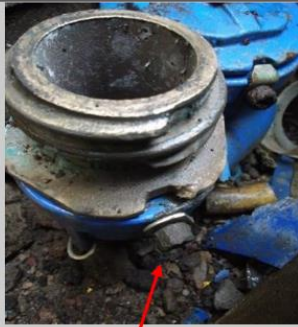
Locking bolt

There have been a small number of Series 19 Fire Hydrants produced by AVK (formerly known as Aqua Gas in the UK) which have failed during operation. In one instance a Fire Officer sustained serious facial injuries when the outlet (where the stand-pipe is connected) was ejected under pressure.

The early versions produced in 1994 to 2001 had a locking bolt which secured the outlet to the body of the hydrant. This could possibly be tampered with having the potential to allow the outlet to fail when under pressure. To date there have been no such examples reported in Anglian Water.

- Inspect all hydrants before operation to ensure the retaining bolts and outlet are secure and avoid using this type of hydrant.
- If you come across any of this type, please use the Aquam Hydrant Finder App to report it. This will send a notification to Anglian Water to complete a repair.

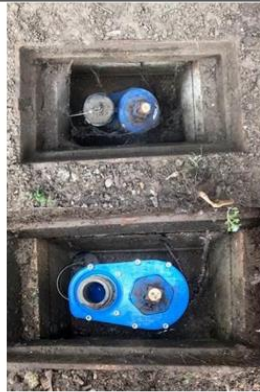
We are compiling a list of affected hydrants and wash outs, so we can take the necessary action to make them safe. A new fitting called the Haldi Clamp has been developed and can be retro fitted to any affected hydrant without risk to the engineer, and without the risks of isolating the main (see above photo on right).

A plan has been devised and put into place to resolve the potential defects, as new clamps arrive with our teams and Network Technician's are trained to fit them.
